Received: 3 May 2011 **Document 6A/512-E 3 May 2011 3 May 2011**

Digital Radio Mondiale

RESULTS OF THE DRM FIELD TRIAL IN BAND I IN TURIN, ITALY

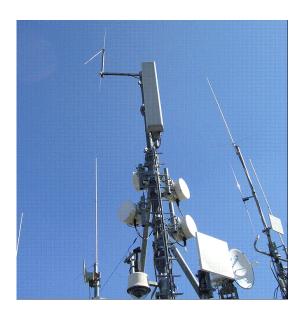
FIGURE 1

The signal was transmitted with 40 W ERP using a ground plane antenna at the highest position of the site tower. The parameters used for Main Service Channel of the DRM+ transmission were 4-QAM at protection level 0, corresponding to a code rate of 1/4. The service parameters are set to transmit only audio. Table 1 summarizes the transmission parameters along with the DRM signal configuration.

Transmitting antenna

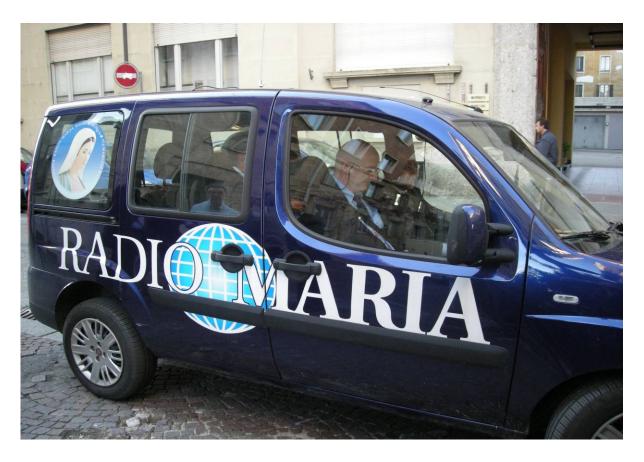
FIGURE 5

The measurement system is based on a professional DRM+ receiver by RFmondial and a monopole antenna. The antenna is installed on top of a vehicle roof. The RSCI parameters were recorded for later analysis and plotting.

Measuring vehicle

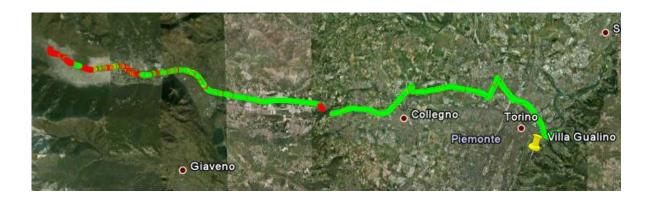
FIGURE 6

Route 1. Audio quality values

The coverage in this route is generally very good. The reception is correct for a 91.5% of its length. The coverage is lost in a tunnel, located in the middle of the route. As the route goes outside the service area, some dropouts appear (further than 30 km from the transmitter). Analyzing the locations where the audio dropouts are noticeable, a MER (S/N) threshold has been identified as 11 dB.

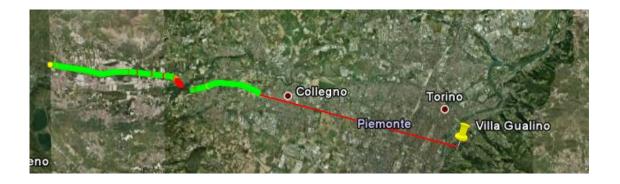
FIGURE 7

Route 2. Audio quality values

The coverage is again excellent except for the same tunnel as the one in Route 1. In this case, 91.6% of the route has excellent reception. The remaining 8.4% corresponds to the above mentioned tunnel, as shown in more detail in Figure 8.

The received signal strength has also been measured along this route. Except for the tunnel, signal strength values are higher than the theoretical threshold for the DRM mode under study, which is set at $27.41~\mathrm{dB}\mu\mathrm{Vm}^{-1}$.

The MER and S/N parameters behave very similarly to the ones in route 1. In this case, according to the values along this route, the S/N threshold is set on 10 dB. In this case the threshold has been obtained using the values around the only dropout section (entrances of the tunnel).

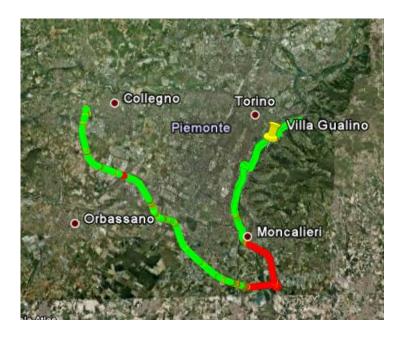
FIGURE 9

Route 3. Audio quality values

The reception is good in 87% of the route, being this route the worst case in this test. This degraded performance was also expected. The route crosses an area outside the expected service area, without direct line of sight from the transmitter, beyond the town of Moncalieri, due to terrain shielding from the mountains to the south of the transmitter. However, the coverage in the urban area is good. The threshold of S/N and MER in this route can be defined on 13 dB.
